# ENERGY EXPERT: ISSUES IN FOCUS

*A quarterly review of disputes and complex issues in the hydrocarbon production and processing industries*

April 2016

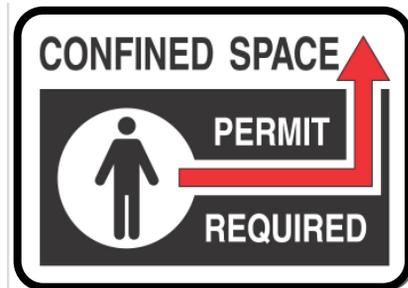
During a turnaround at a petrochemical plant, a “flash” fire occurred in a pressure vessel after it had been cleared for entry and workers had already begun performing their work inside. A flash fire is a sudden, intense fire caused by ignition of a mixture of air and a combustible liquid or gas characterized by high temperature and short duration. Fortunately, no one was severely injured, and damage to equipment was minimal. However, because of differing views on who was at fault, Baker & O’Brien was retained to identify factors that may have contributed to the incident.

The flash fire occurred following several days of activities inside the vessel, after a work crew had already exited. It flashed outside of the vessel and quickly self-extinguished. In this particular case, prior to workers entering the vessel, it had been treated with a hydrocarbon solvent to remove as much residue as possible, and then flushed with water to remove all flammable liquids. Correctly performing such activities is important in order to clear the vessel of all hazardous and flammable materials before work activities begin.

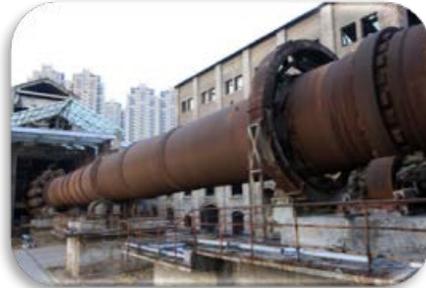
Flue gases from the kiln's burners pass through the ESP, which uses high voltage electrical wires to impart a negative charge to the dust particles which are then attracted to positive (grounded) plates. The accumulated dust particles fall by gravity into collection bins at the precipitator's base. ESPs are common air pollution control devices used across a wide range of industries, such as refineries and power plants.

a "flameout" at the kiln's burners that went unnoticed for almost 20 minutes. A flameout is the sudden extinguishing of the burner flame. In this case, unburned hydrocarbon-rich gases continued to pass through the kiln's burners until they were ignited by sparks in the ESP. Because ESPs use high voltage electricity, there is always a potential for sparking, which makes it imperative that the flue gas entering the ESP not contain any combustible gases. The facility remained down for an extended period of time following the explosion until repairs could be completed. Baker & O'Brien consultants provided a report on our findings to the owner and its insurer to support decisions regarding coverage and potential subrogation.

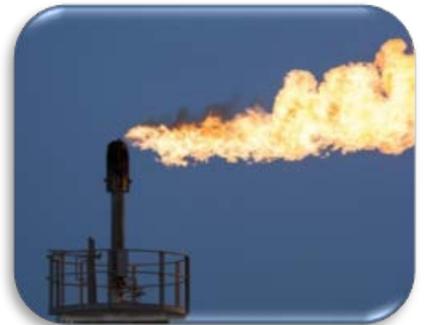
As part of their assignment, Baker & O'Brien consultants reviewed the damage in light of what would typically be expected for a flare with a similar operating history. This evaluation included examination of the old flare tip to determine whether erosion was typical for the flare's age, and historical wind and flame patterns during normal operations. We also examined the wear patterns on the stainless steel to carbon steel welds near the tip. Our opinions were presented in a report submitted during mediation proceedings. The owner and the insurance company eventually settled the claim.
